Long Term Performance of Soloflo drainit Wedge Design

2010 Inspection of Sub-Soil Drainage Pipe Installed at Meerlust Wine Estates in 1985.

by Falk Hedrich, Geosynthetic Technology Consultant, RSA

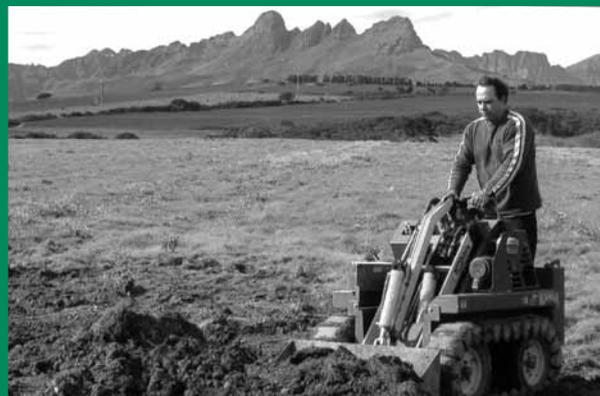
Excavation of Pipe

With the help of a small earthworks machine we removed the soil to a depth of approximately 800 mm and carefully hand-tool excavated to the top of the pipe to avoid damage. The 200 mm main drainage pipe was exposed at two different places, namely 15 meters and 45 meters from the manhole exit. We did not deem it necessary to excavate towards the smaller free flowing pipes. Soil samples were taken from above the pipe, namely 80 mm and 800 mm away from the pipe. Four samples were taken in total – two at each location. No free water was present around the pipe. On average the pipe was covered by a mixture of soil consisting of 5 – 10% clay, 10 – 20% silt, 37-45 % sand and 34-41% gravel and a plasticity index of between 9 and 11.

We may point out that the night before we excavated towards the pipe there was 6 mm of rainfall. This moisture is clearly seen in the picture still contained in the upper level of the soil above the pipe and still in the process of migration towards the drainage pipe. The area around the pipe was free of standing water (*Fig. 2*). Therefore, one can assume that the drainage process is a slow ongoing process and not a quick rapid drainage process. The drainage process is influenced by the permeability of the soil. When the pipe was installed in 1985 the trench was excavated, the pipe placed and the trench backfilled with the previously excavated material without the addition of any natural drainage materials such as stone or any artificial geosynthetic materials (*Fig. 1*). Unfortunately no soil samples were taken for testing in 1985 that we know of. The advice and prediction given by the late Mr Tony Kothmann, the inventor of SOLOFLO, that the DRAINIT pipe will perform under the existing site conditions has clearly been confirmed.

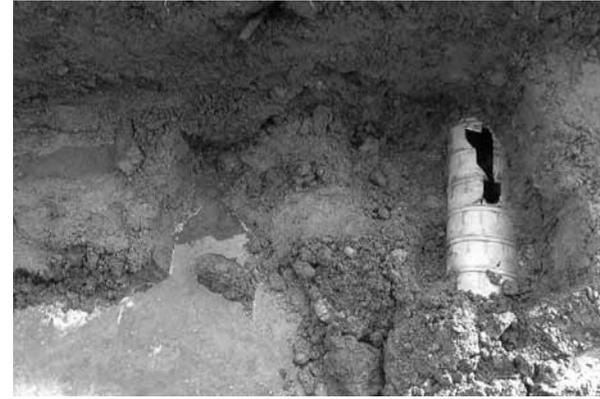
Fig. 2 - No Standing Water Around Pipe

A further pipe section was exposed approximately 50 meters away from the manhole for the purpose of opening the top of the pipe to retrieve A.B.S samples and to inspect the inside of the pipe manually. The small pieces of soil visible in the picture of the opened up pipe are soil particles which fell into

the pipe when it was opened (*Fig. 2*). The water level and the inner wedge slot opening can be clearly seen (*Fig. 3*). Small root growth visible in the pipe was only noticed in 2 or 3 places. No root growth network was present in the pipe.

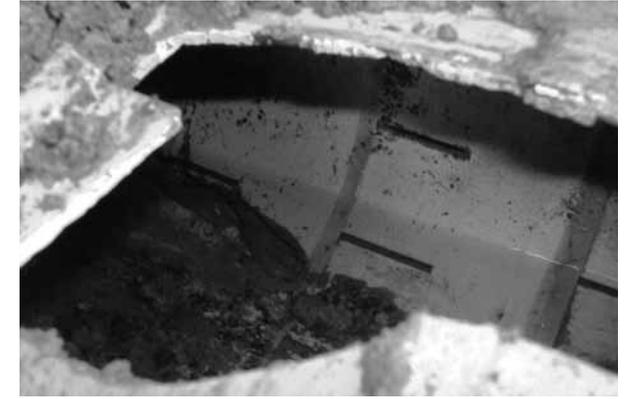
Fig. 3 - Flush I.D. Joints and Wedge Design Openings

circumference of the pipe where drainage water can enter the pipe. A further contributing factor is that the inside of the pipe is flush, free of stepped joints or flow hindering connections (Fig. 3). The TV camera could enter the pipe for a distance of 26 meters which was the limit of the inspection capacity.
